Initial Feasibility Analysis Report

For Flood Control at Foxcroft Colony Condominiums and
Mosby Woods Condominiums, and Stream Restoration at Daniels Run

City of Fairfax, Virginia

May 2013

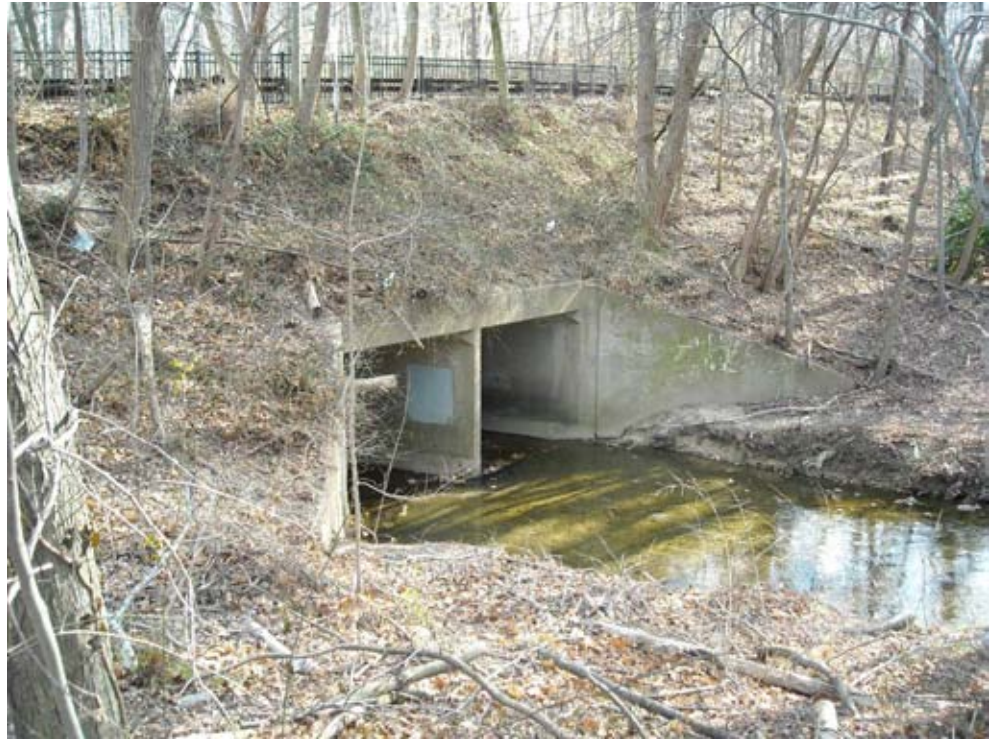
Photo 12

Culvert located
downstream of the
Mosby Woods
Condominiums at
Stafford Drive.

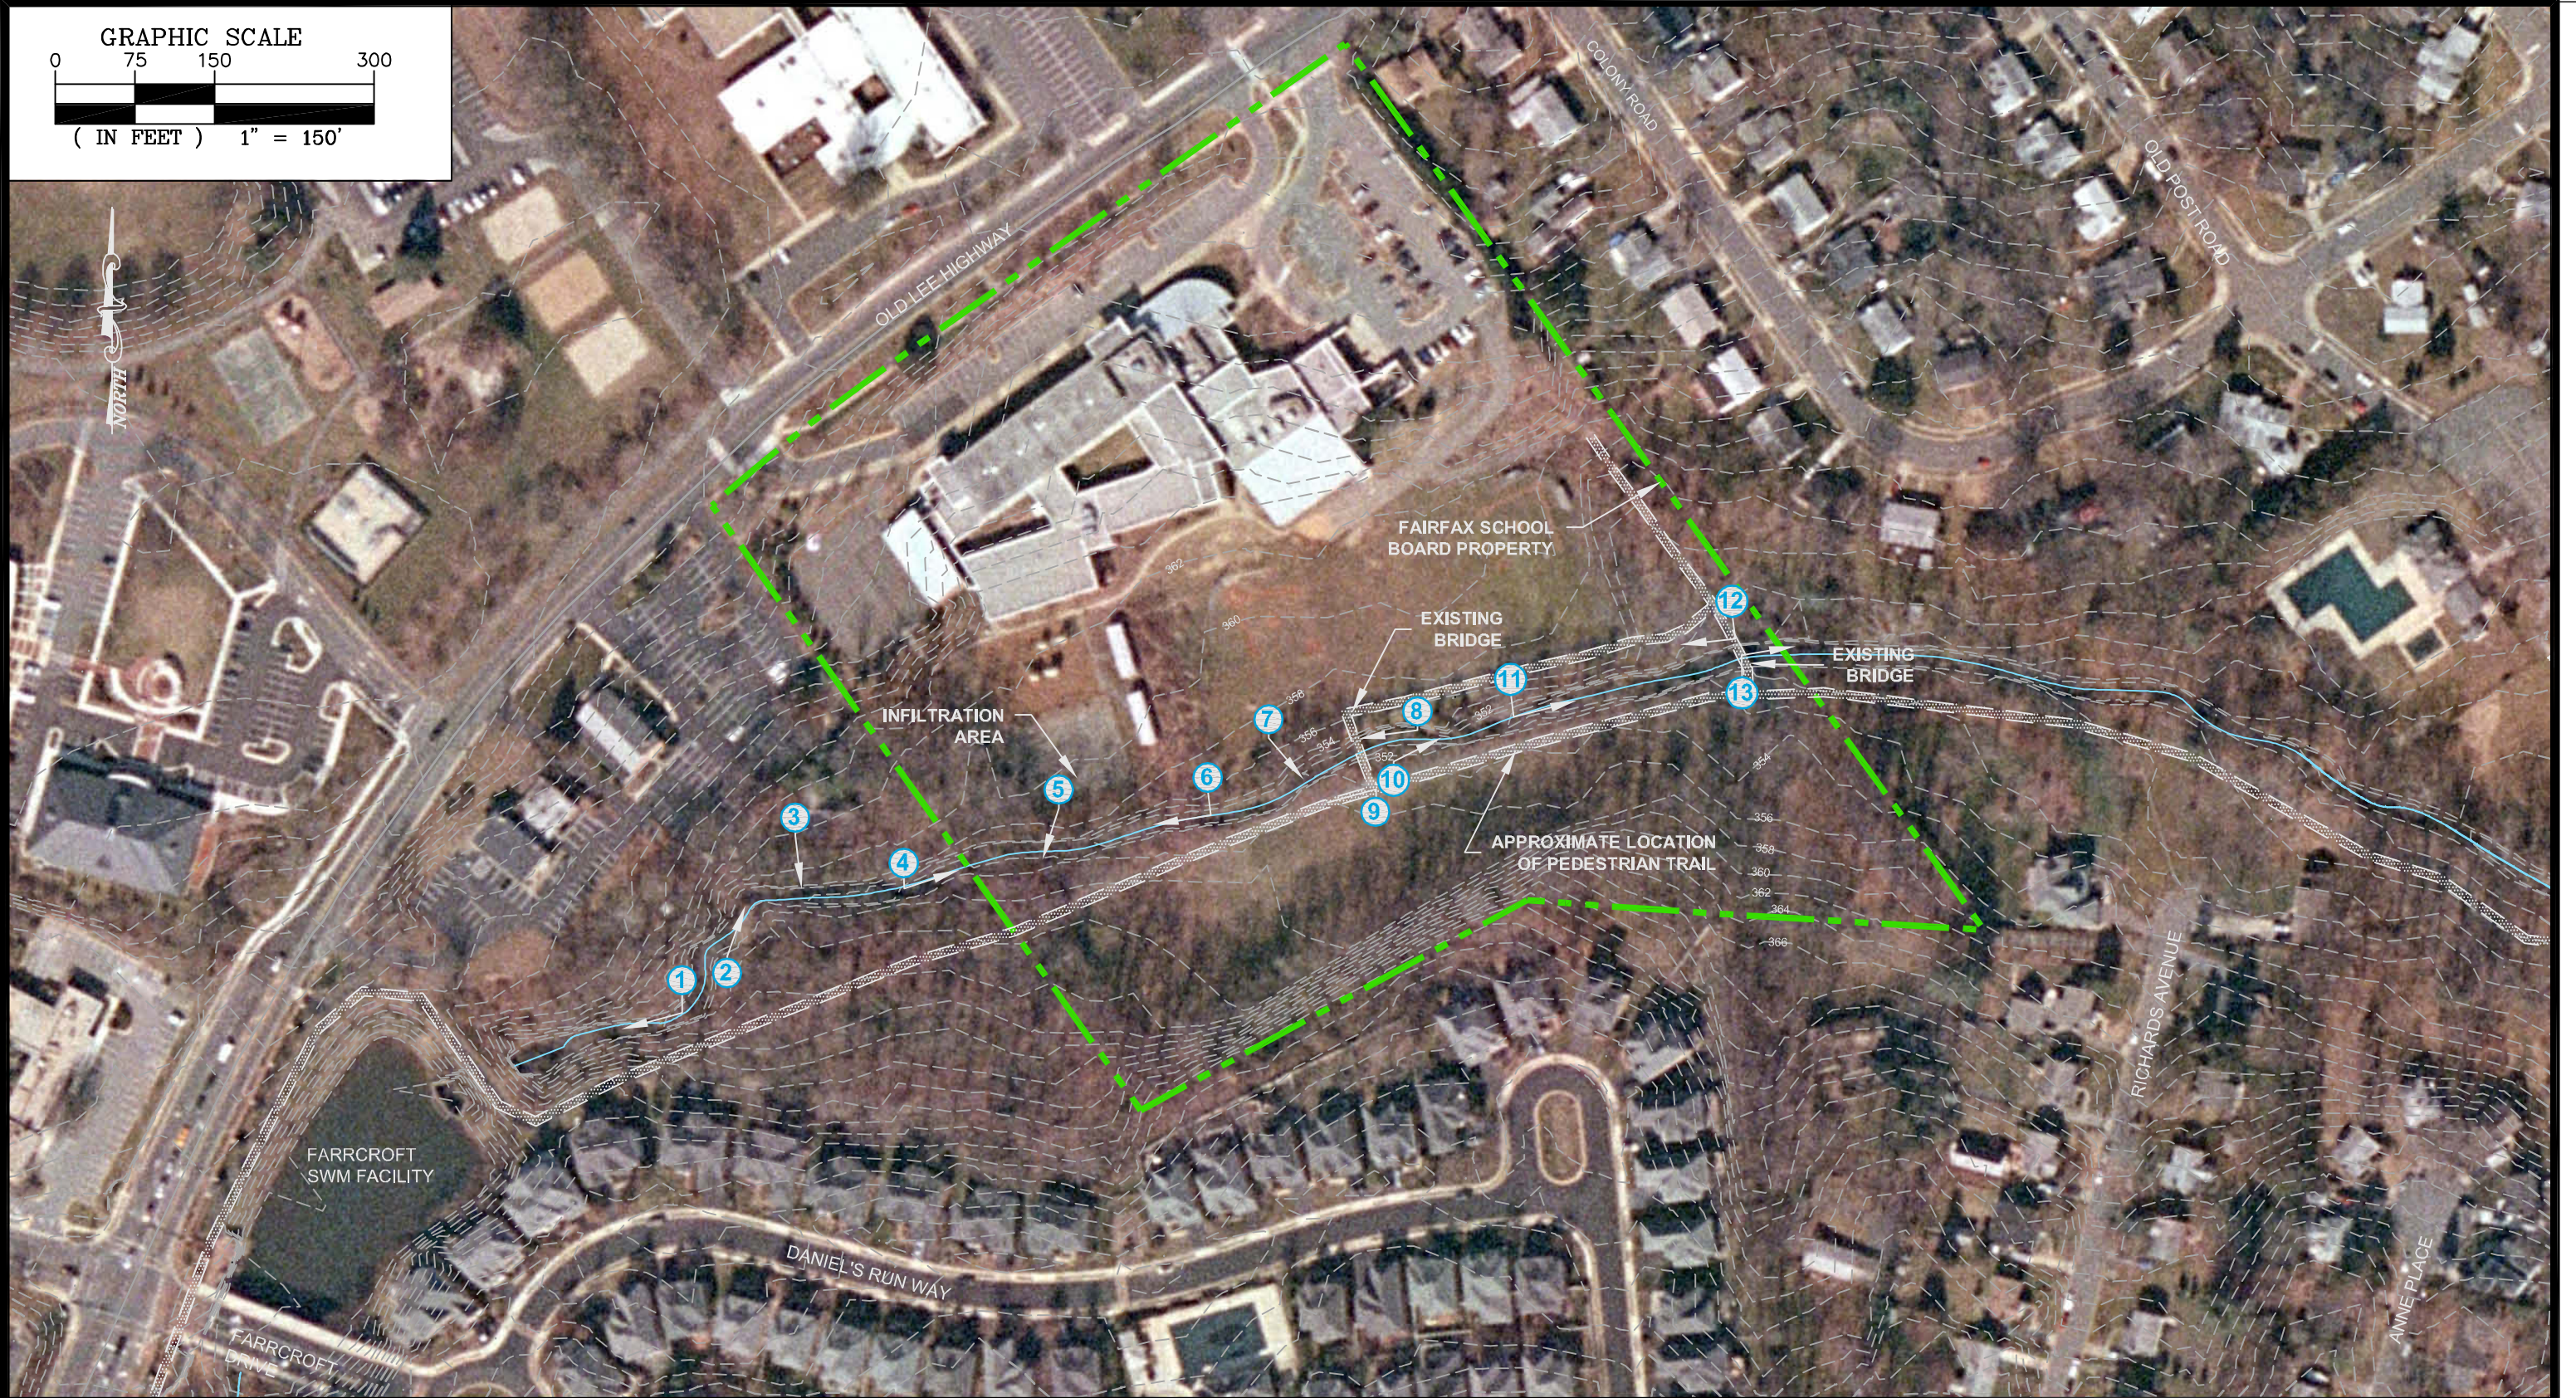
Design	Draft	Approved	V Datum: NGVD 29	Daniel's Run Elementary School Conceptual Stream Restoration Plan City of Fairfax	
FRG	FRG	FRG	H Datum: NAD 88		
Sheet # 1 of 1			Boundary/Topo Source: City of Fairfax GIS City of Fairfax GIS		
			Scale: 1" = 150'		
File Name: 22234.01 Concept Base.dwg			Date: March 2013	Copyright © 2013 Wetland Studies and Solutions, Inc.

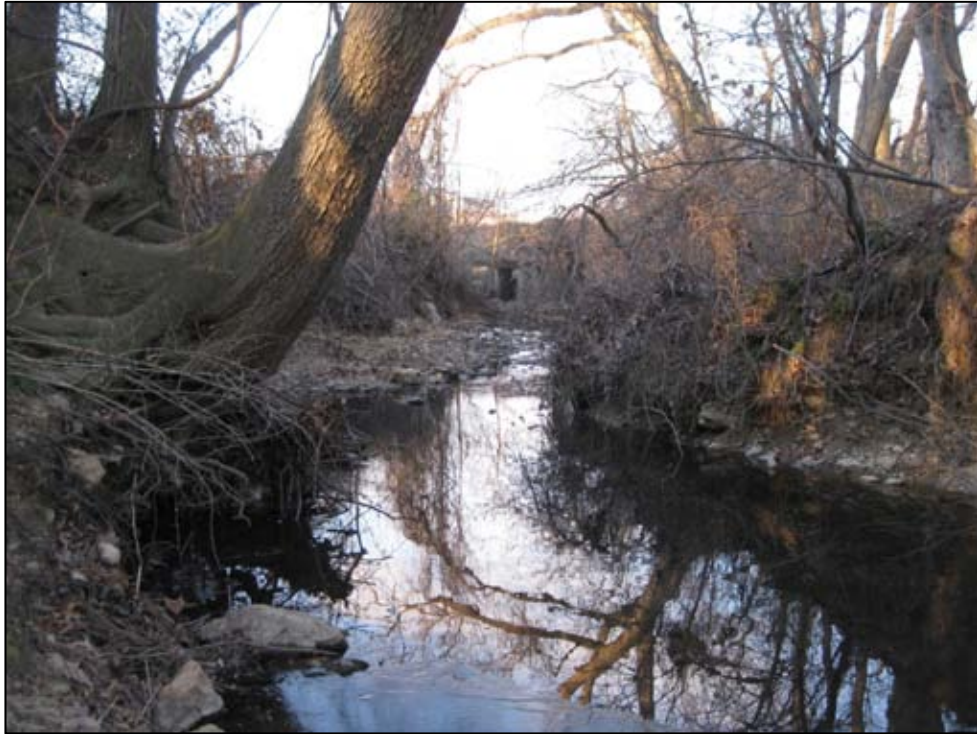
1. Looking upstream toward the Farrcroft SWM Facility. Channel is deeply incised with eroding banks.

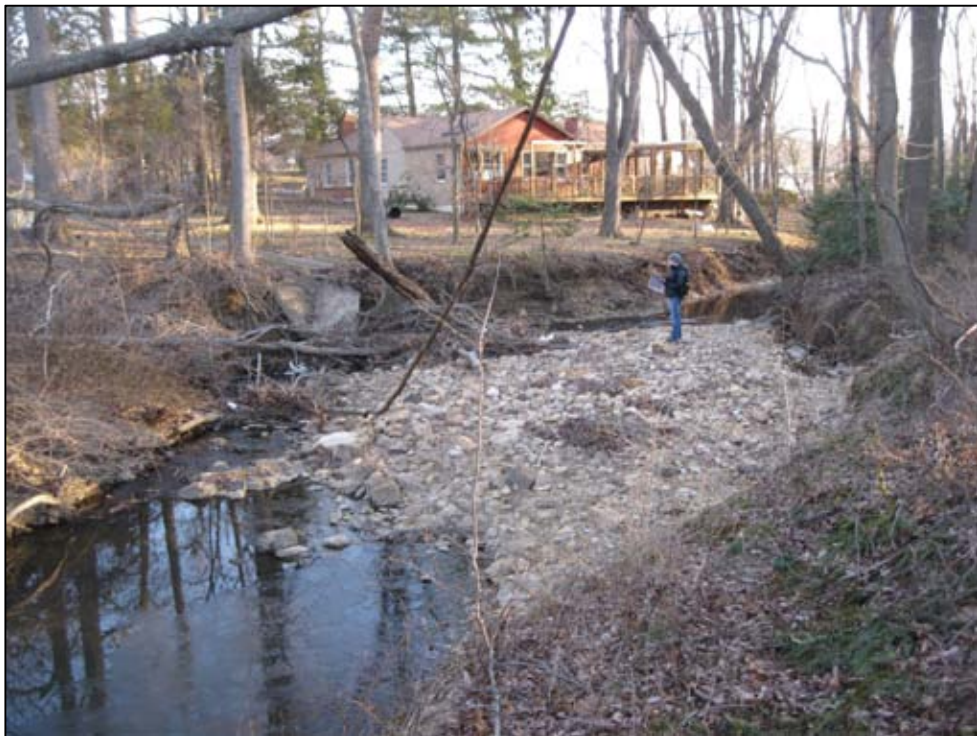
2. Looking downstream toward the structure located in the floodplain. Collapsed concrete channel section evident on left bank.

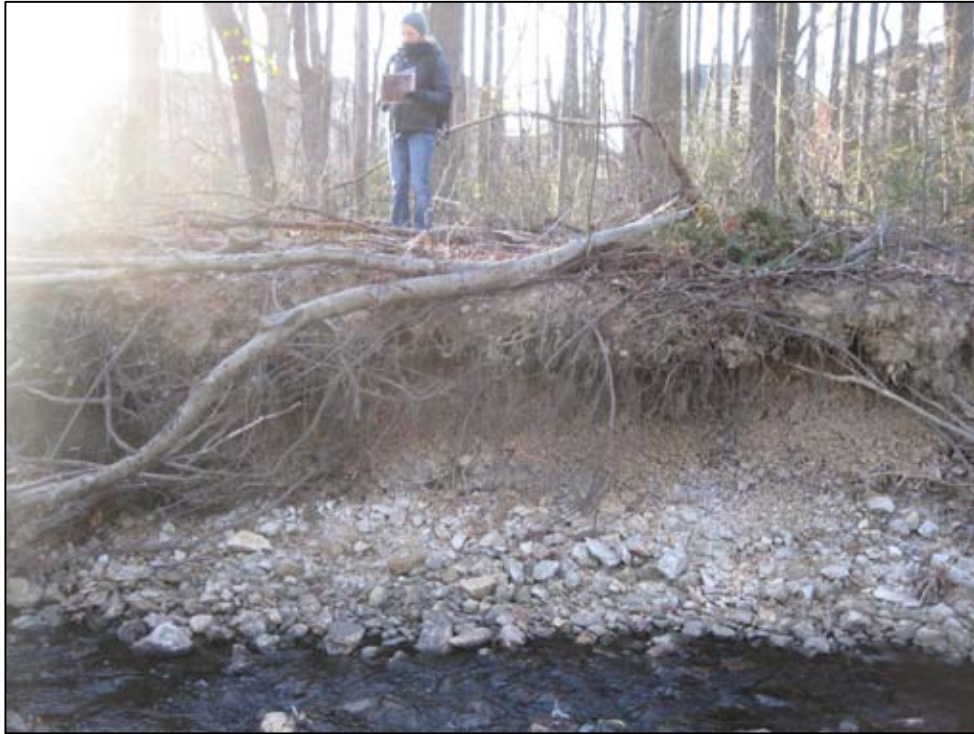
3. Eroded right bank – note layer of larger sediment.

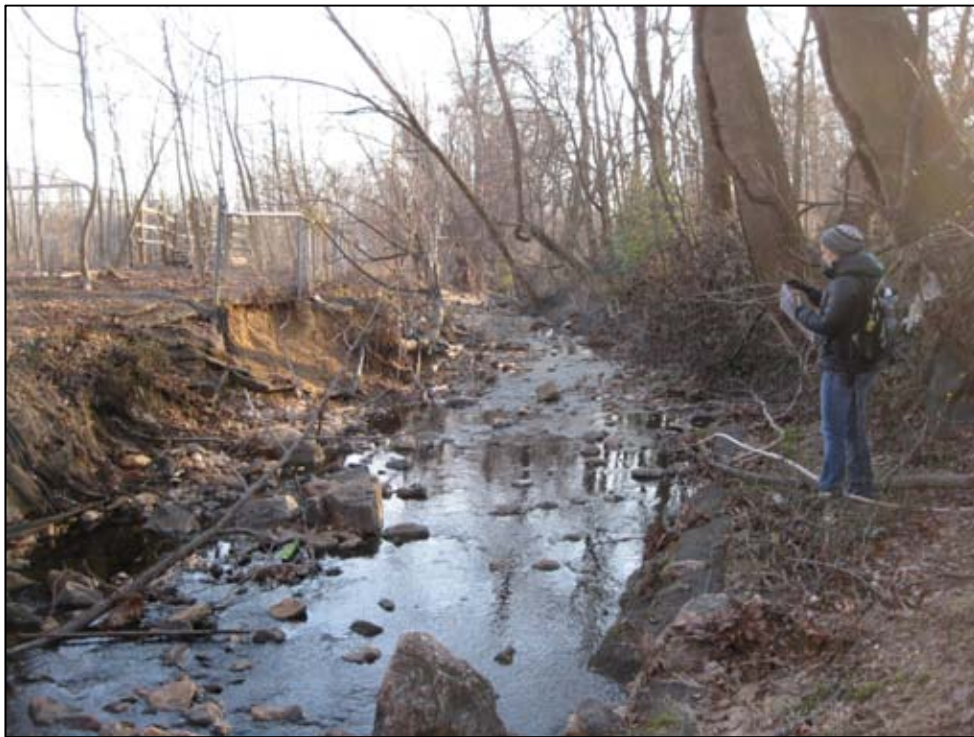
4. Looking downstream toward the school property line. Fence posts have been exposed where Filtrexx® restoration has washed away.

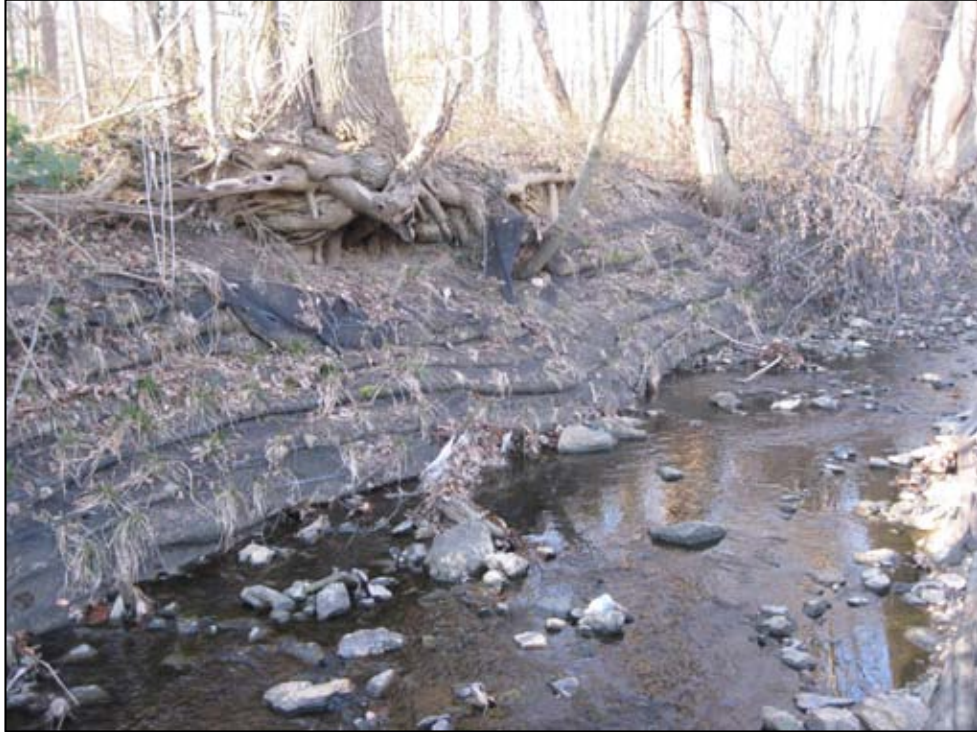
5. Vertical right bank with failing Filtrex® restoration.

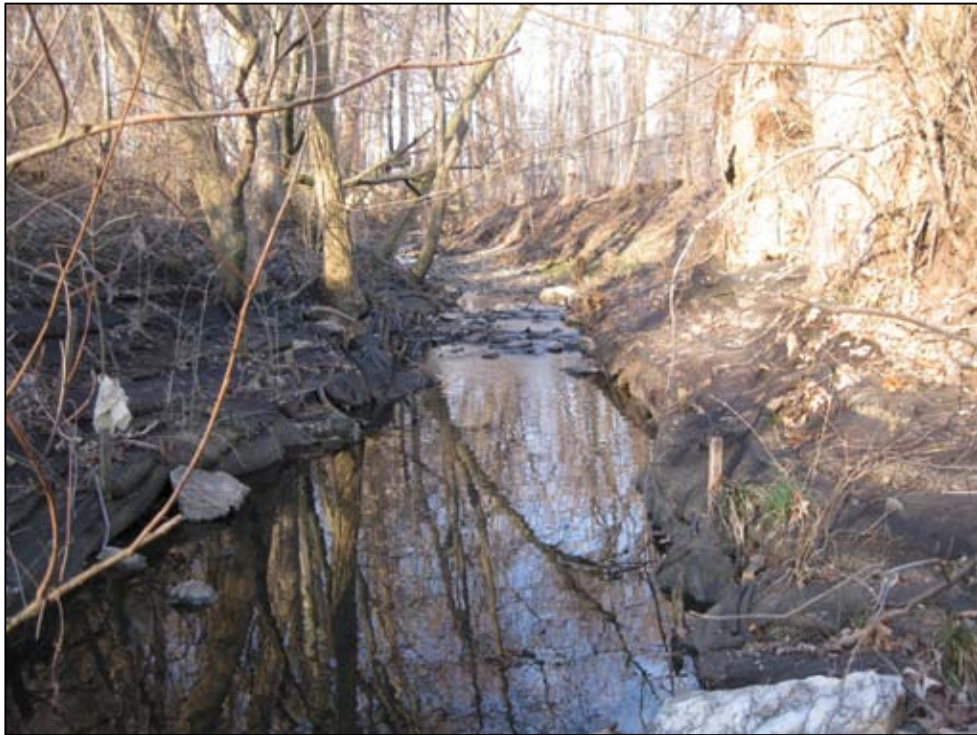
6. Looking upstream adjacent to the school's infiltration area project.
Filtrex® restoration is failing.

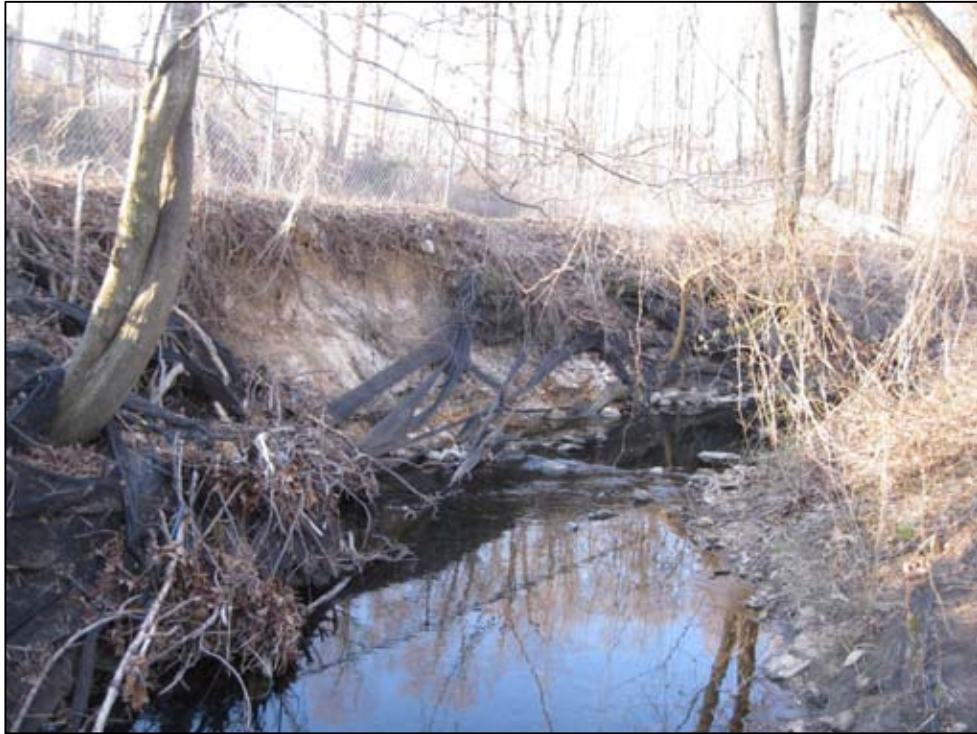
7. Vertical bank threatening fence adjacent to the play area across from the school. Filtrex® restoration has failed.

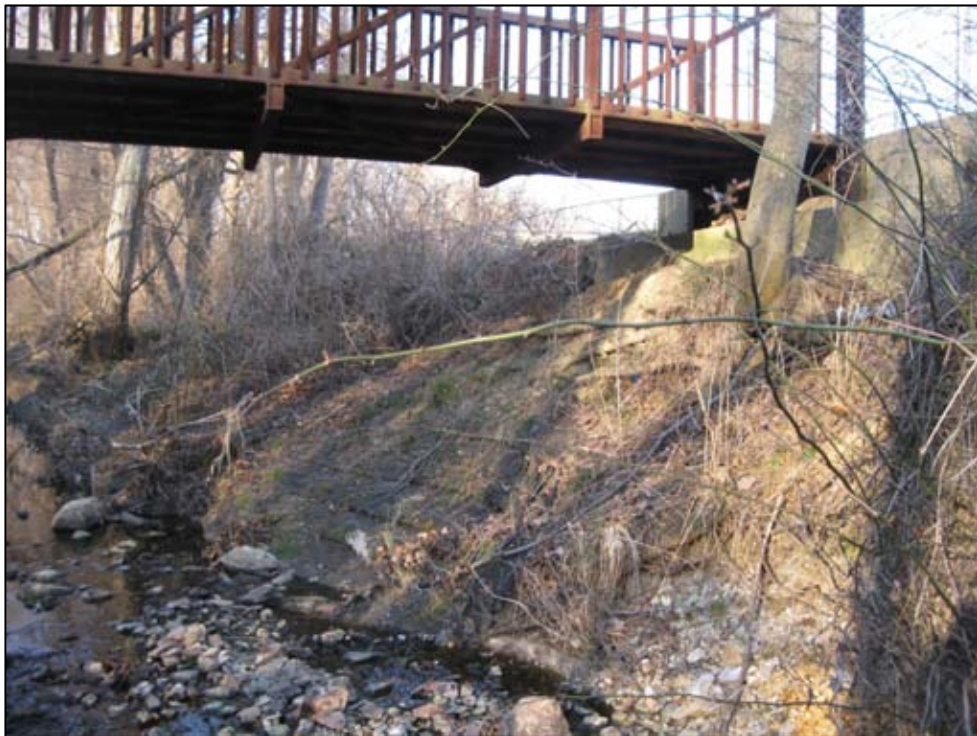
8. Vertical bank under the bridge abutment.

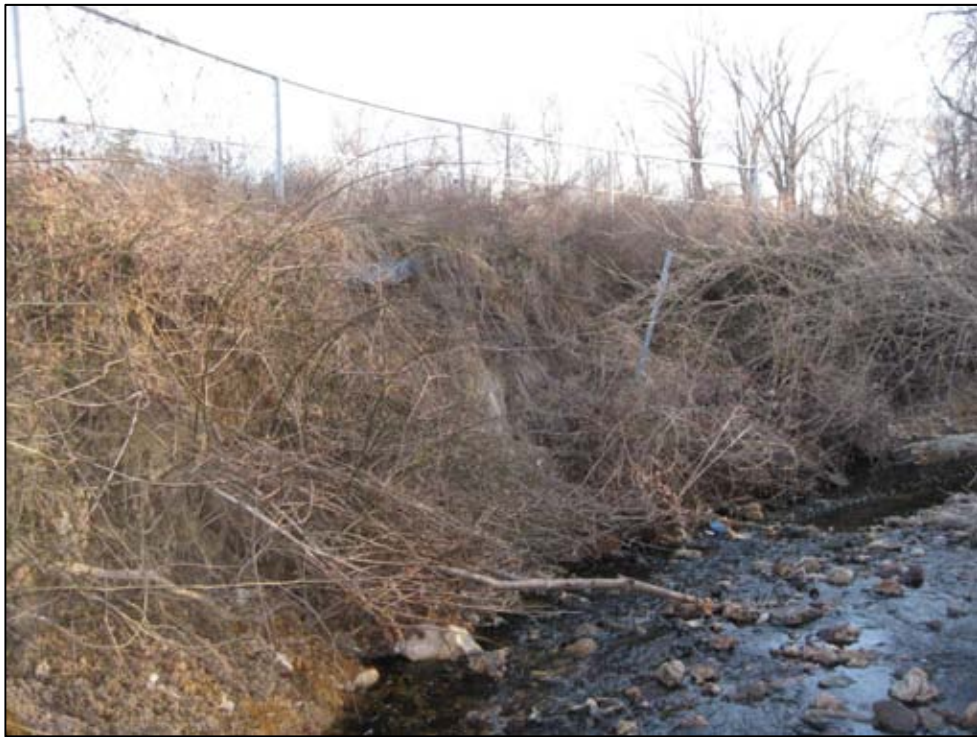
10. Vertical bank threatening fence line on school property.

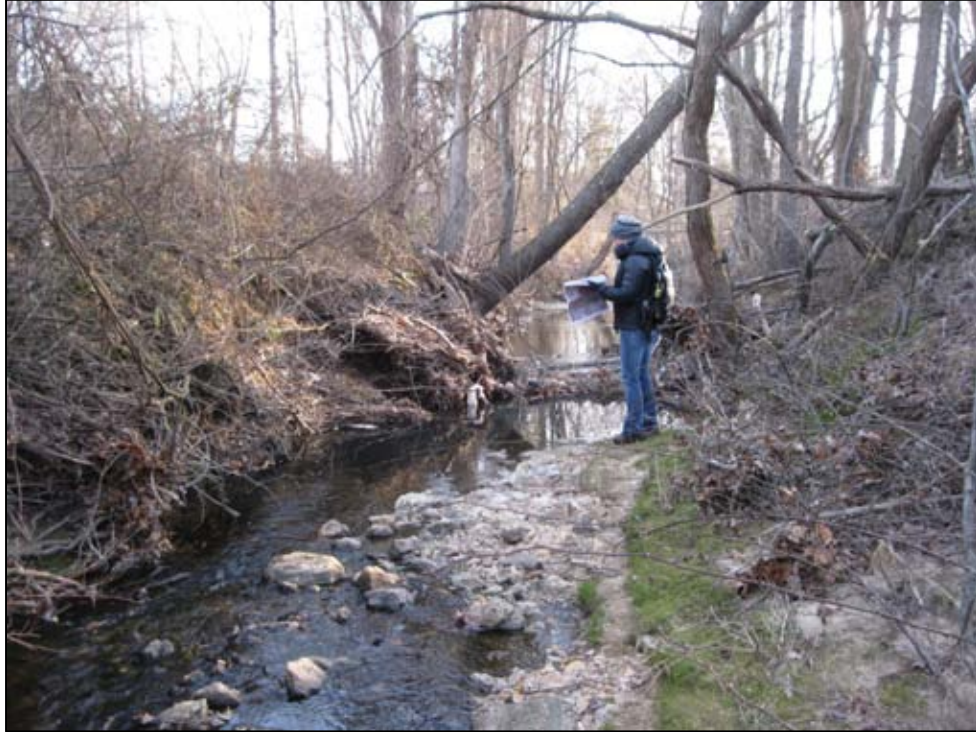
11. Looking downstream. Confined channel with eroding banks and tree loss.

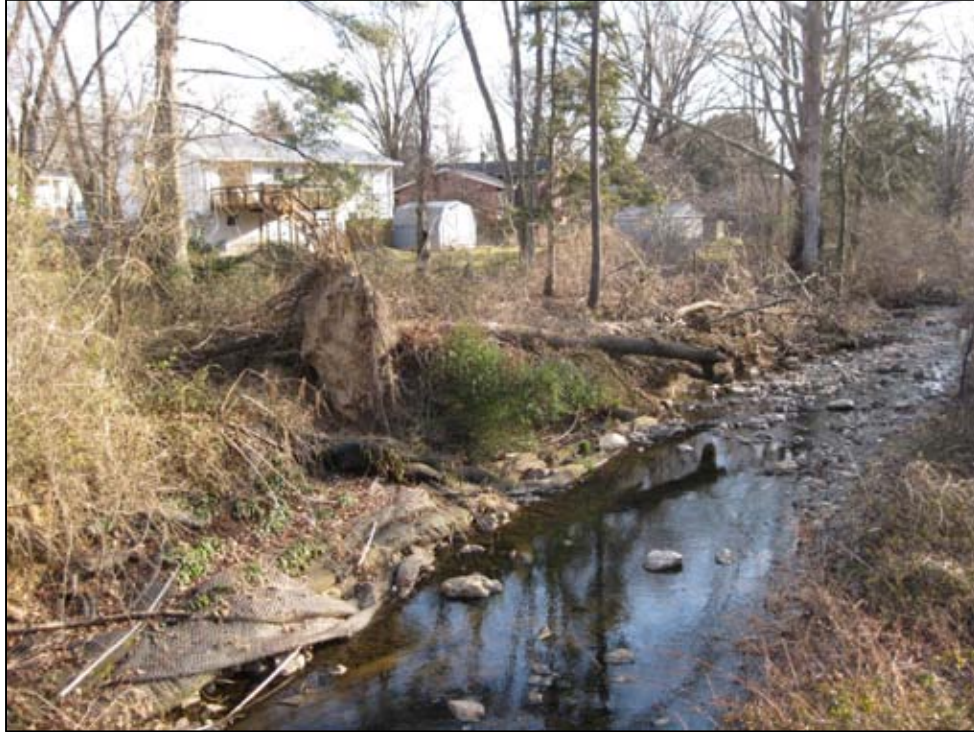
13. Looking downstream just below the school property line. A large tree has recently fallen.

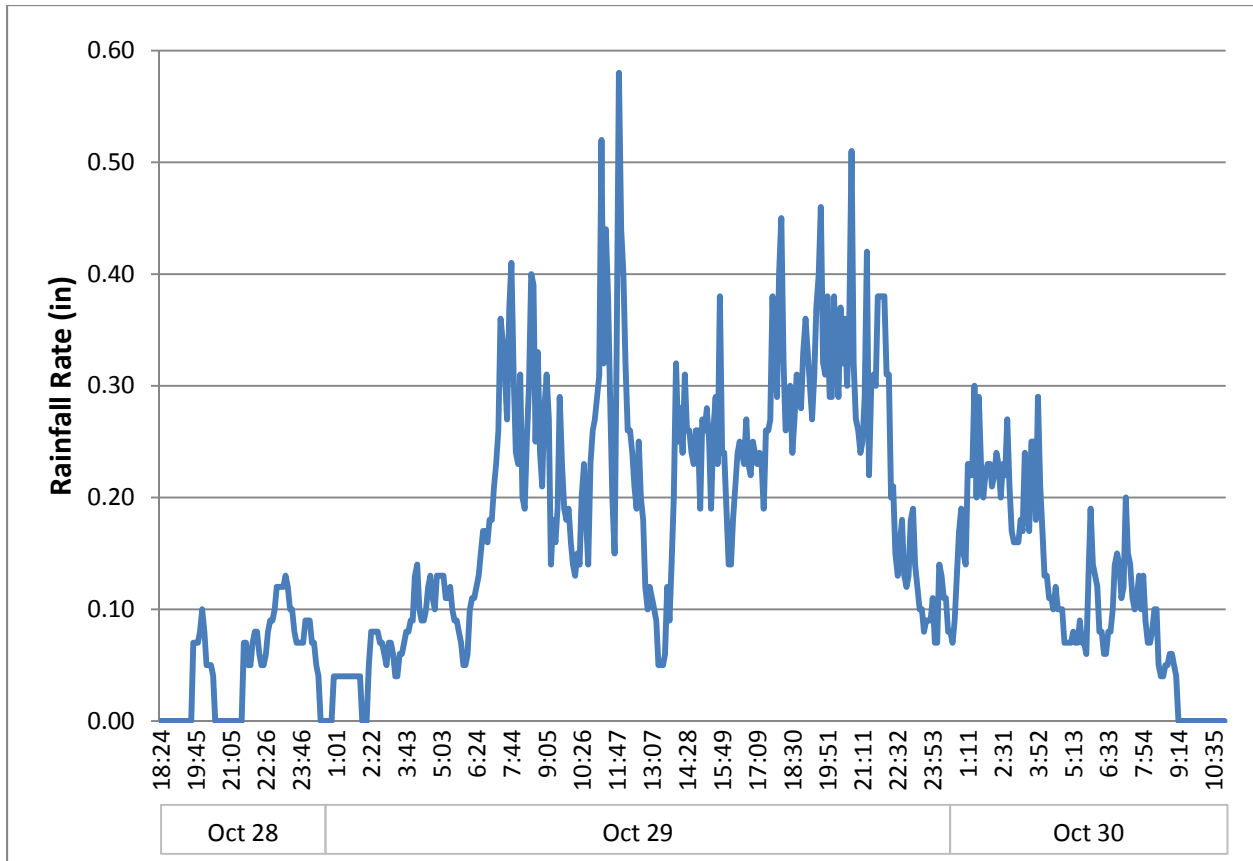
Chart F-1. Hurricane Sandy (2012) Rainfall vs. Time

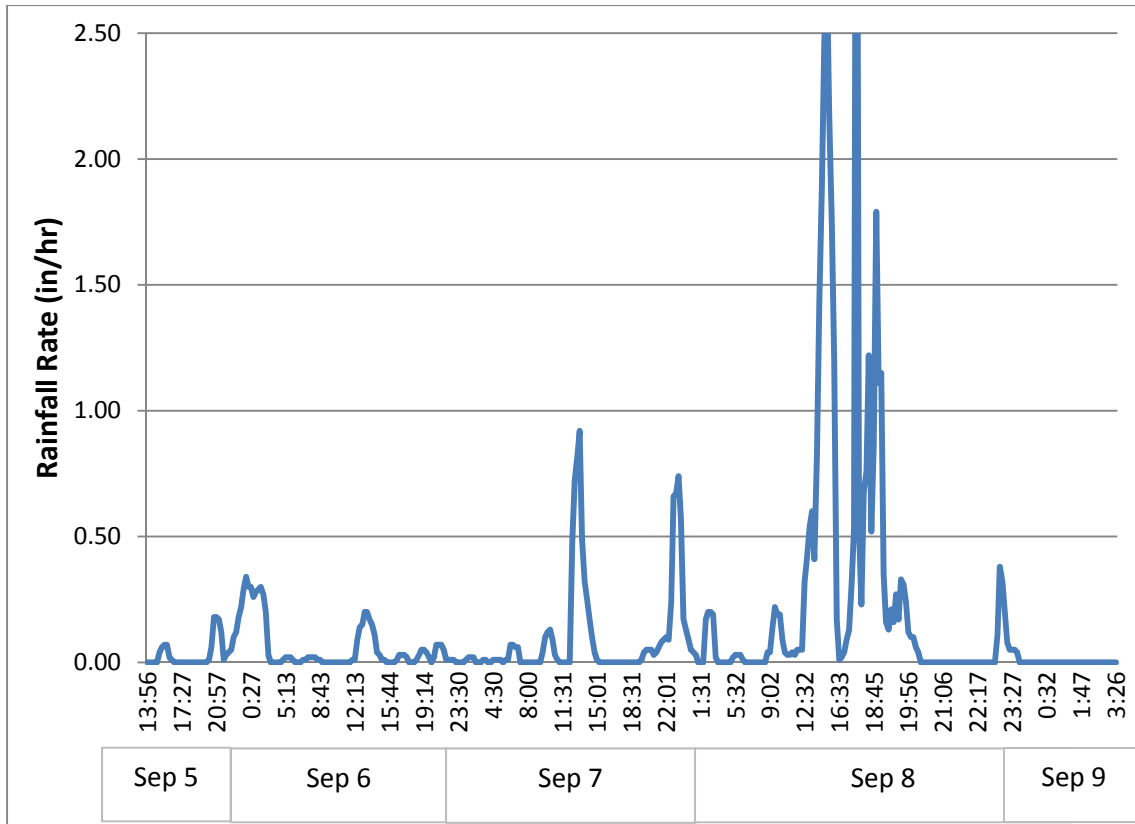
Chart F-2. Tropical Storm Lee (2011) Rainfall vs. Time

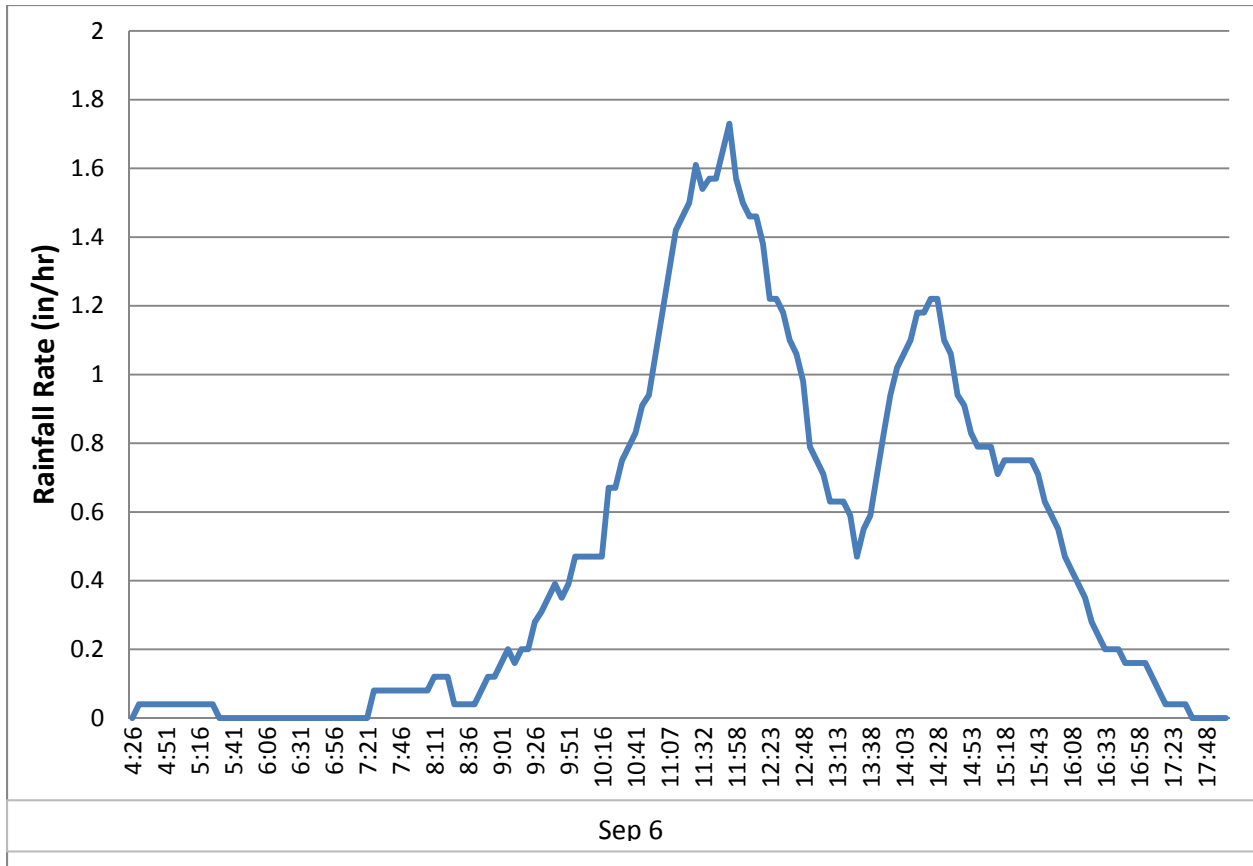
Chart F-3. Hurricane Hanna (2008) Rainfall vs. Time

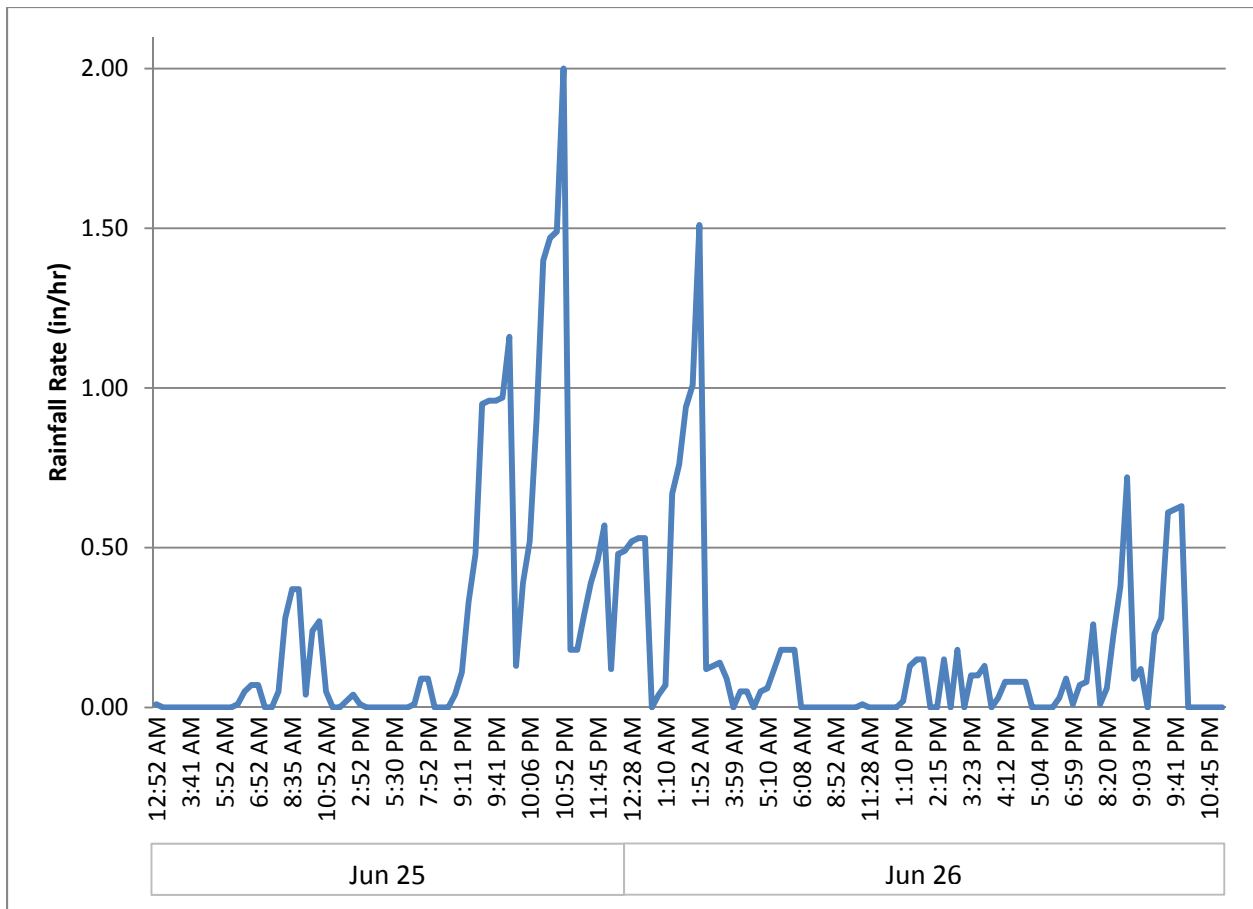
Chart F-4. Unnamed Tropical Cyclone (2006) Rainfall vs. Time
